National Highway Traffic Safety Administration

ON-SITE AIR BAG INVESTIGATION

CASE NO. - 96-12 FLEET - PRIVATE VEHICLE LOCATION - NORTH CAROLINA ACCIDENT DATE - 1996

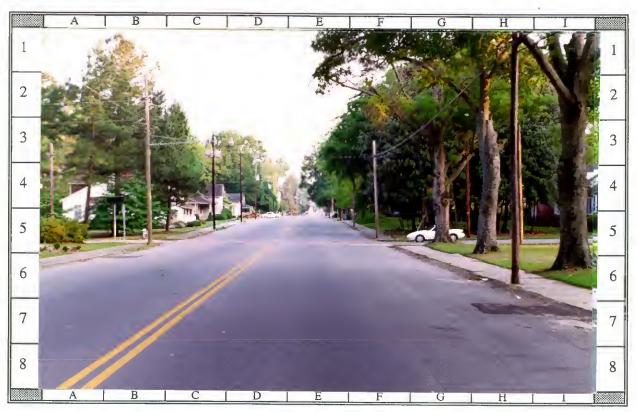
01: Case Vehicle's southward travel path in southbound lane approximately 30 meters (98 feet) north of impact in intersection

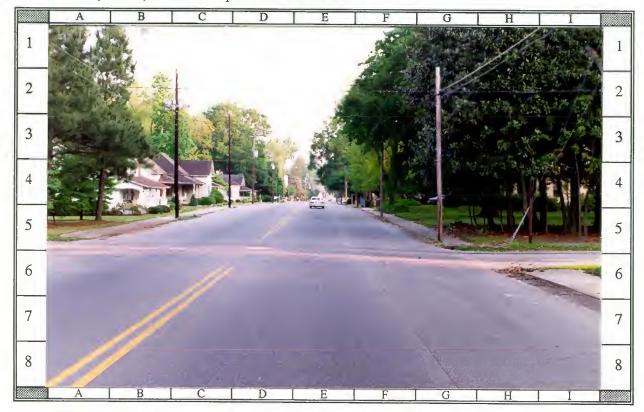
02: Case Vehicle's southward travel path in southbound lane approximately 15 meters (49 feet) north of impact in intersection

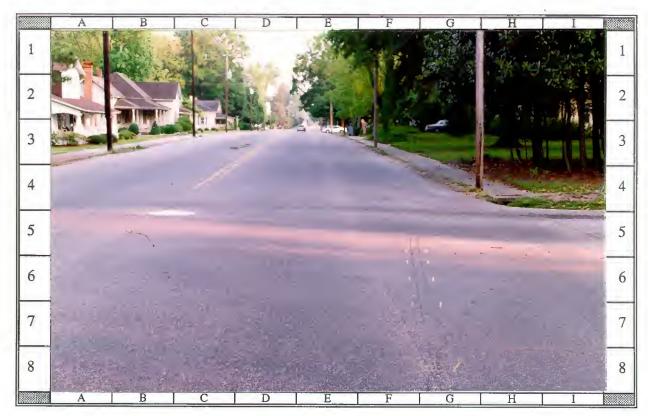
03: Case Vehicle's southward travel path in southbound lane approximately 5 meters (16 feet) north of impact; NOTE: right front skidmark

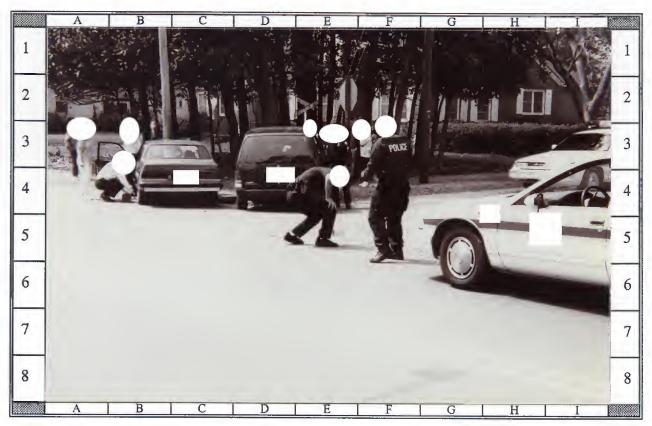
05: On-scene view looking south-southwest showing both vehicles at final rest; NOTE: police officers are marking case vehicle's deflection point

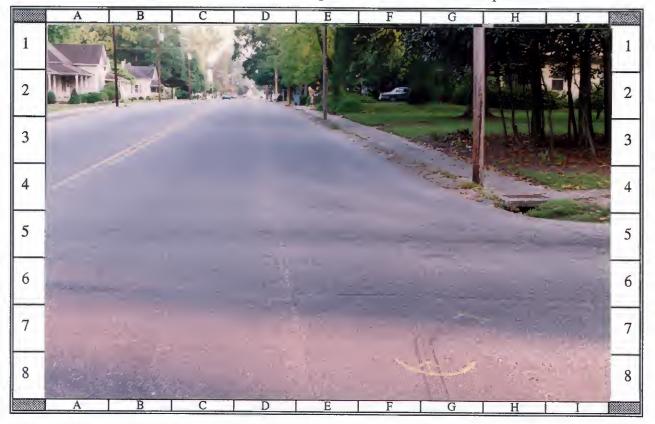
06: Case Vehicle's southbound travel path at points of impact and maximum engagement with Vehicle #2; NOTE: case vehicle's deflection scuff

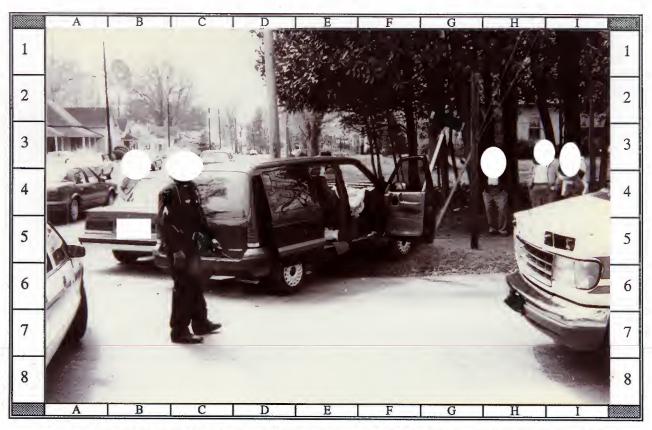
07: On-scene view looking south at case vehicle's final rest position against street sign post; NOTE: post had not been replaced at time of our scene inspection

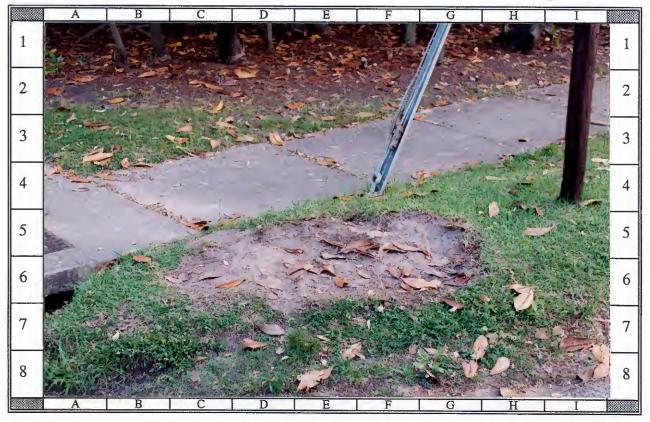
08: Southwest view of Case Vehicle's final rest position; NOTE: Case Vehicle's air dam scraped ground and bumper impacted sign post before coming to rest

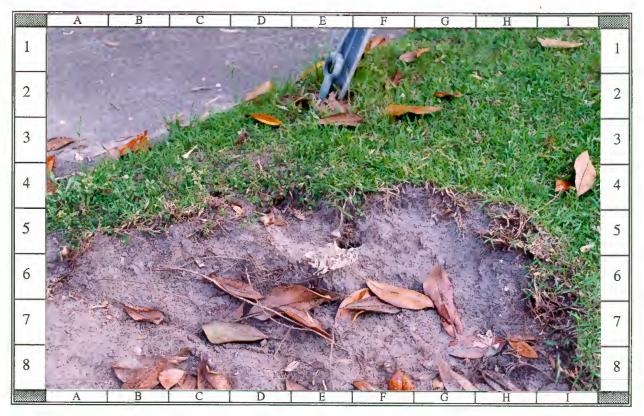
09: Close-up of southwest corner of intersection showing ground and cement base of sign post struck by Case Vehicle's front

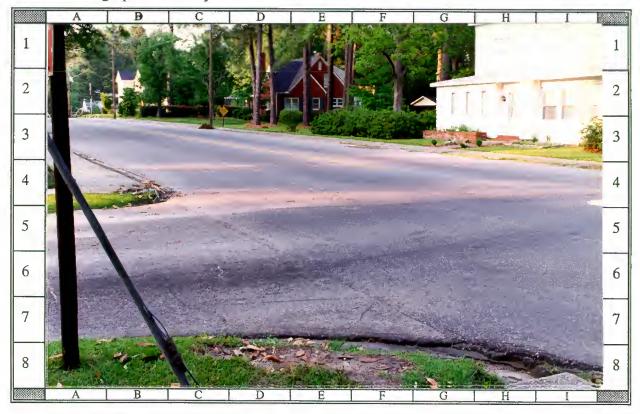
10: Northeastward view of Case Vehicle's southwest travel path taken from beyond final rest area showing area of impact with Vehicle #2

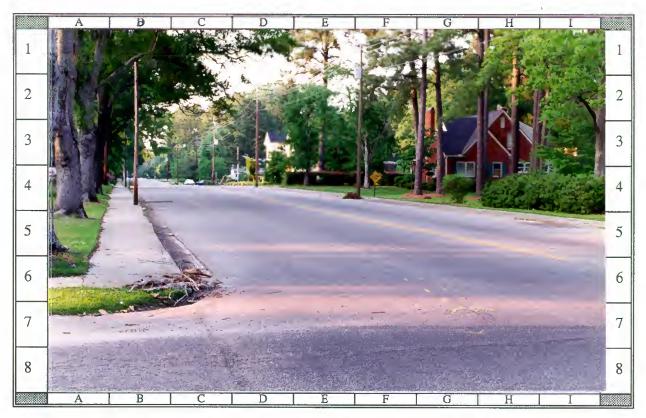
11: North-northeastward view of Case Vehicle's southbound travel path from just beyond area of impact; NOTE: skidmark and deflection point in intersection

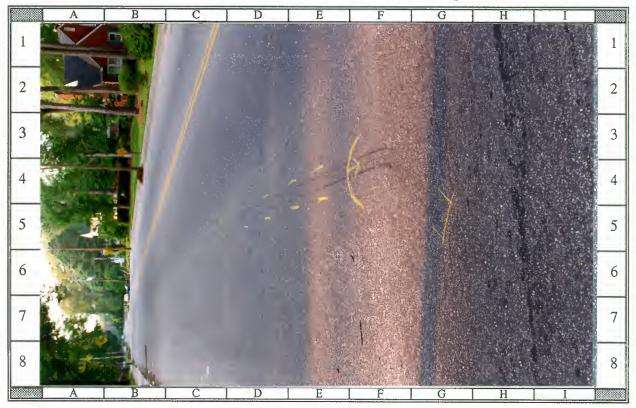
12: Northward close-up of skidmark and deflection point deposited by Case Vehicle's right front tire

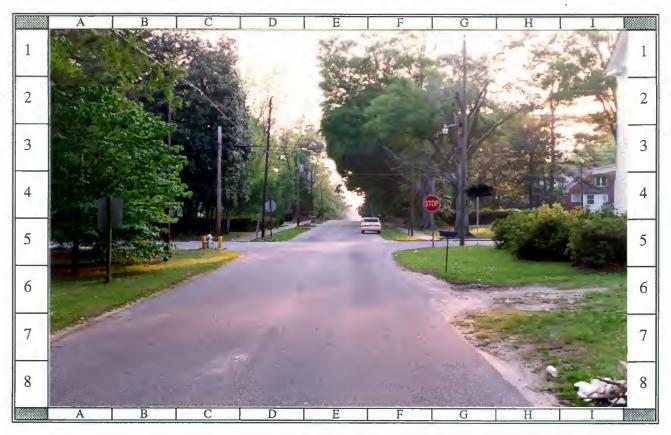
13: Vehicle #2's westward travel path in westbound lane approximately 30 meters (98 feet) east of impact in intersection

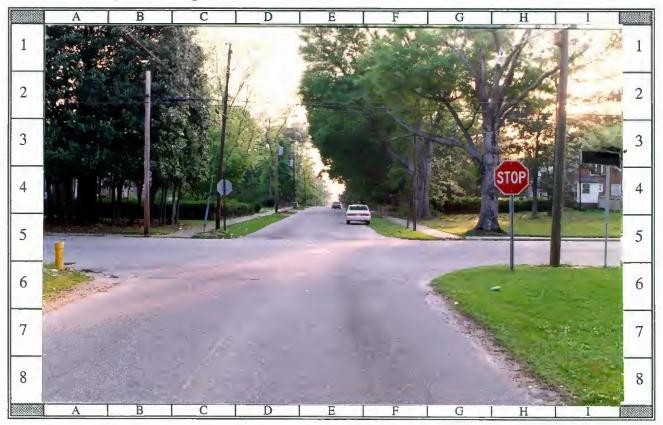
14: Vehicle #2's westward travel path in westbound lane approximately 15 meters (49 feet) east of impact in intersection

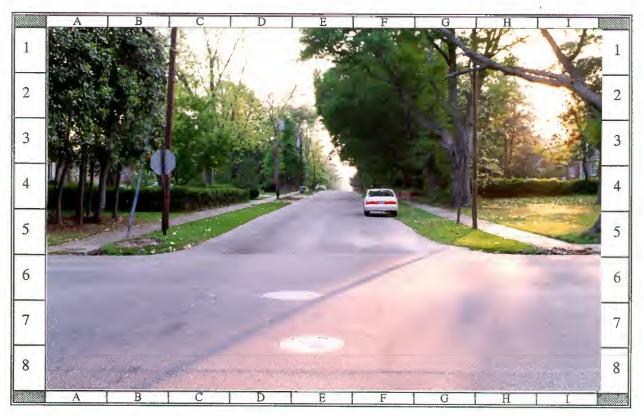
15: Vehicle #2's westward travel path in westbound lane approximately 5 meters (16 feet) east of impact in intersection with Case Vehicle

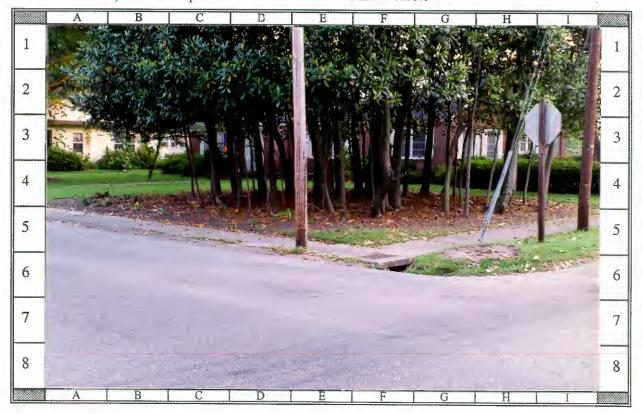
16: Vehicle #2's southwestward travel path post-impact with Case Vehicle; NOTE: Vehicle #2 subsequently struck utility pole on southwest corner of intersection

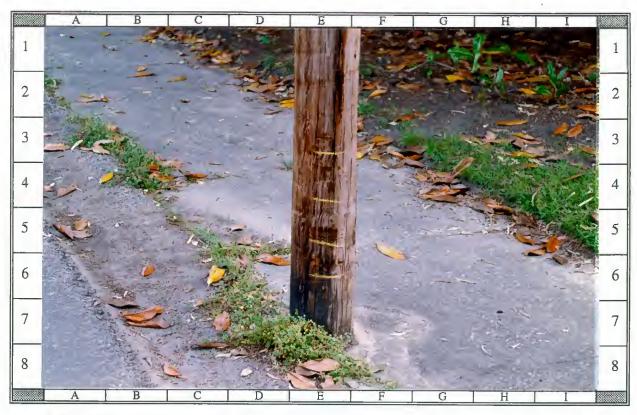
17: Close-up view, looking southwestward, of utility pole on southwest corner of intersection struck by Vehicle #2

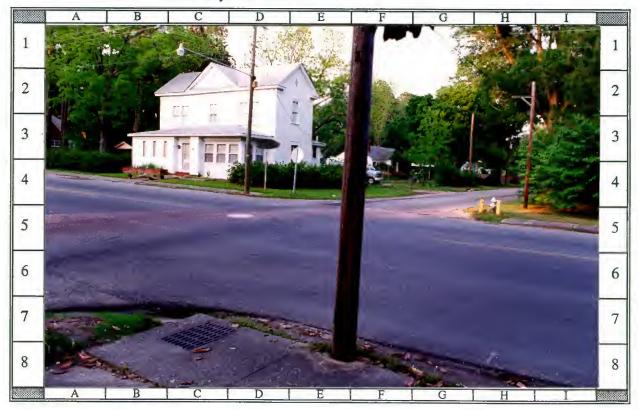
18: Northeastward view of Vehicle #2's post-impact trajectory taken from beyond final rest showing Vehicle #2's final rest position against utility pole

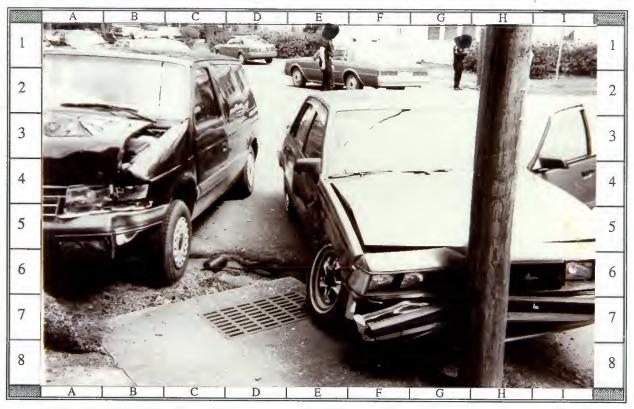
19: On-scene view, looking northeastward, showing Case Vehicle and Vehicle #2 at their respective final rest positions

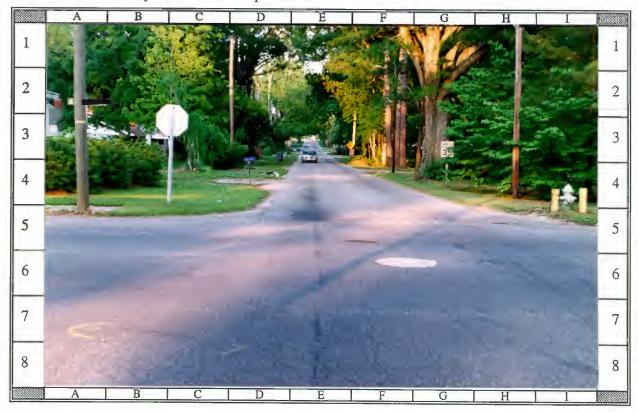
20: Eastward view of Vehicle #2's westward travel path from just beyond area of impact; NOTE: Case Vehicle's deflection mark in foreground

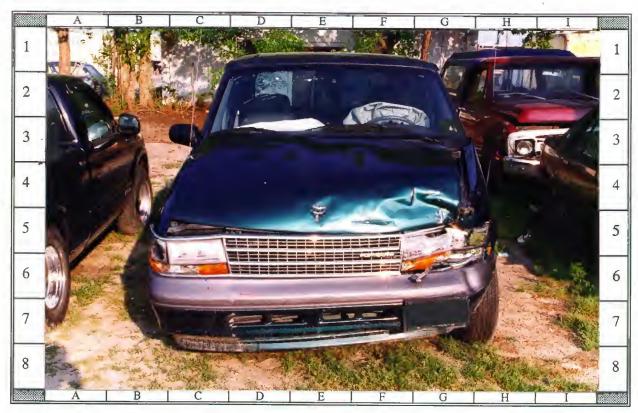
Case Vehicle's damaged front without contour gauge present; NOTE: shifting # 21: of front bumper to right

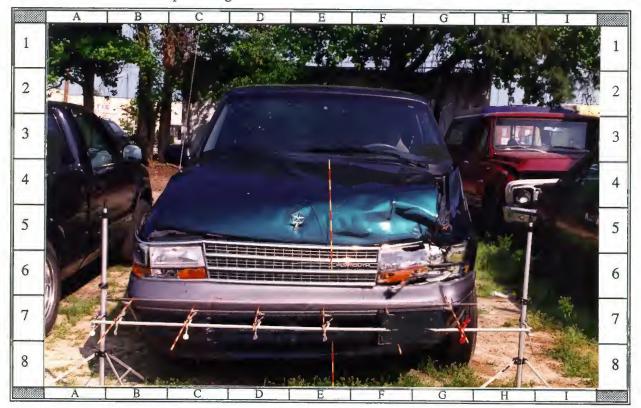
22: Case Vehicle's damaged front with contour gauge present; NOTE: direct damage extends across entire front

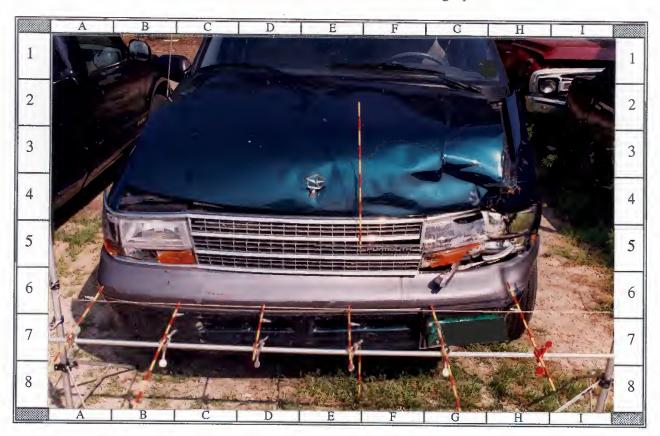
23: Close-up of Case Vehicle's front damage with contour gauge present; NOTE: sign post damage to bumper (cells C6--C7)

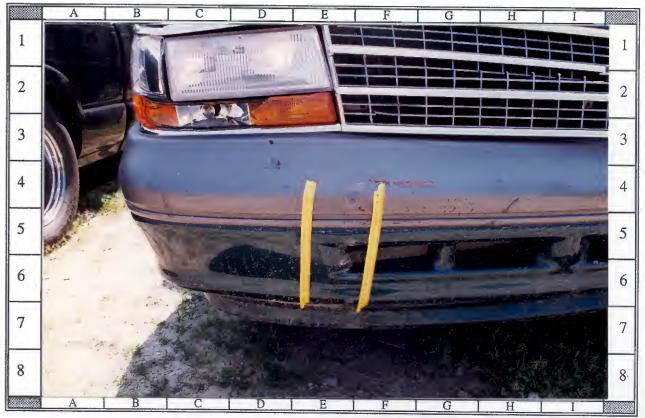
24: Close-up of sign post impact to Case Vehicle's front bumper; NOTE: reddish scuff is most likely from 1986 Chevrolet Celebrity

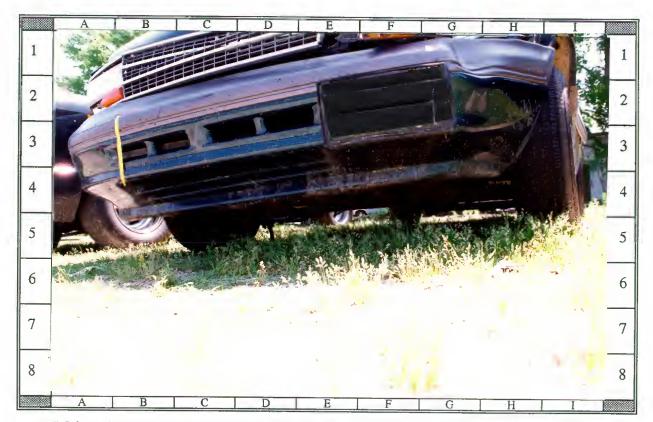
26: Close-up of Case Vehicle's air dam which contacted ground just prior to Case Vehicle's impact against sign post

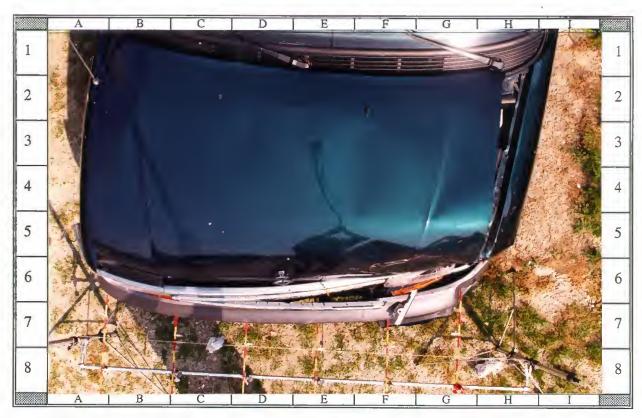
27: Overhead view of to Case Vehicle's frontal damage; NOTE: contour gauge shows damage profile

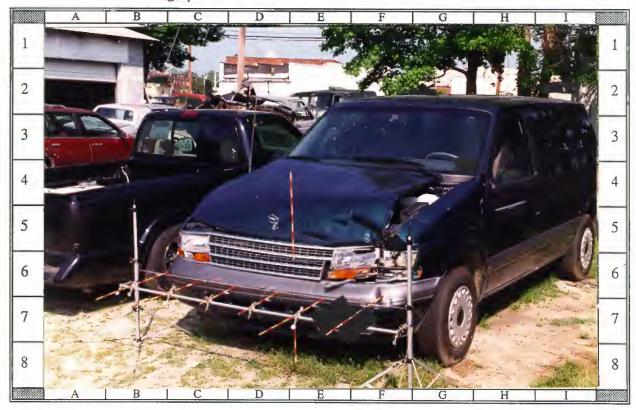
28: Case Vehicle's damaged front viewed from approximately 45 degrees left of front with contour gauge present

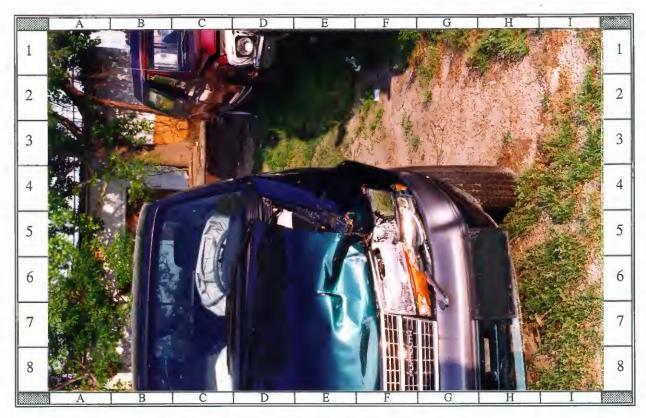
29: Reference line view of Case Vehicle's left side from front showing front bumper's rightward shift

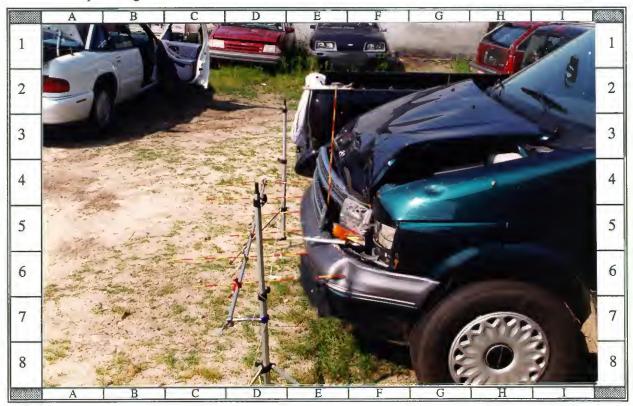
30: Reference line view of Case Vehicle's damaged front from left with contour gauge present

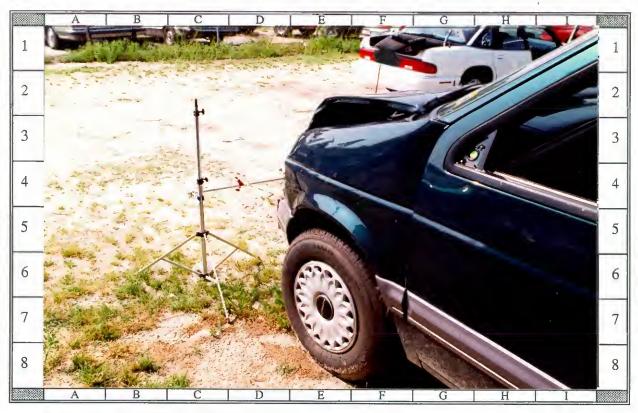
#31: Case Vehicle's left fender, viewed from ~ 45 degrees left of back, showing induced damage and shifting which caused left front tire restriction

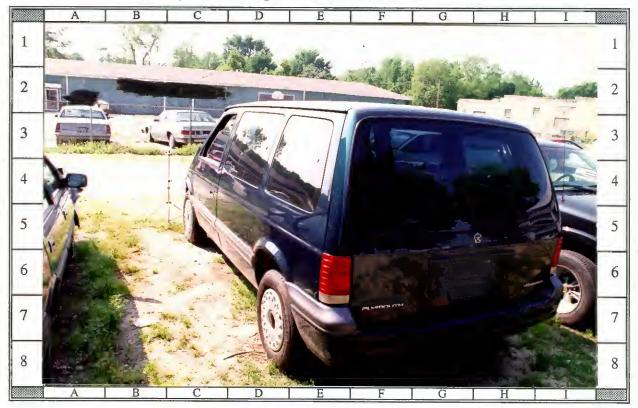
32: Case Vehicle's undamaged left side (except fender) and back viewed from approximately 30 degrees left of back

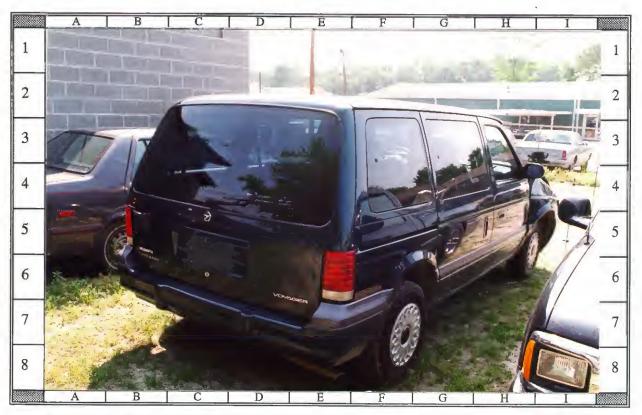
33: Case Vehicle's undamaged right side (except fender) and back viewed from approximately 30 degrees right of back

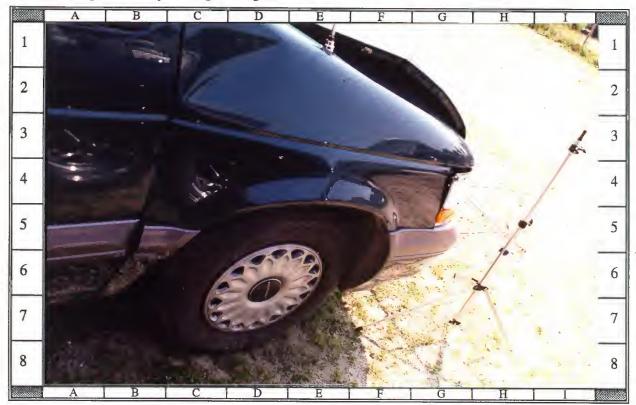
34: Case Vehicle's right fender, viewed from ~ 60 degrees right of back, showing induced damage from bumper shift which caused right front tire restriction

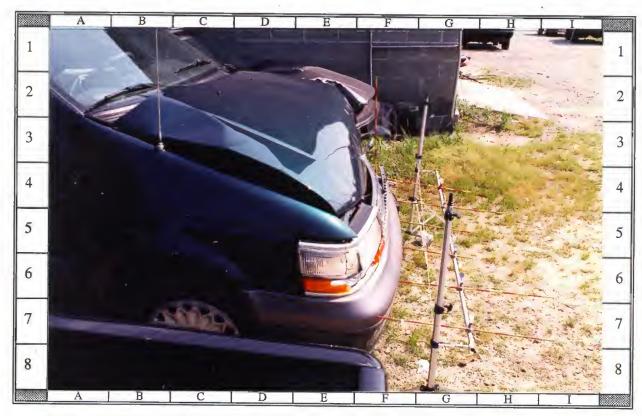
35: Reference line view of Case Vehicle's damaged front from right with contour gauge present

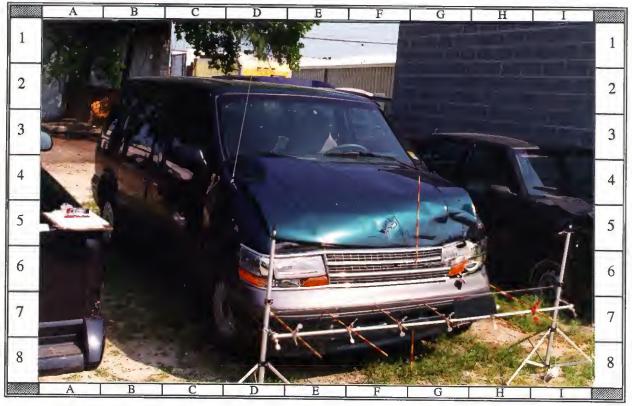
36: Case Vehicle's damaged front viewed from approximately 30 degrees right of front with contour gauge present

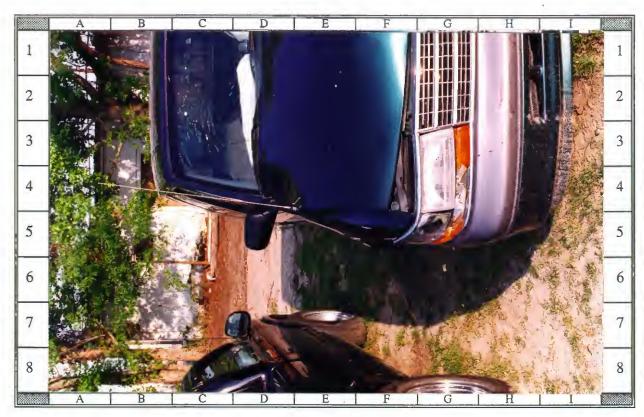
37: Reference line view of Case Vehicle's right side from front showing front bumper's slight rightward shift

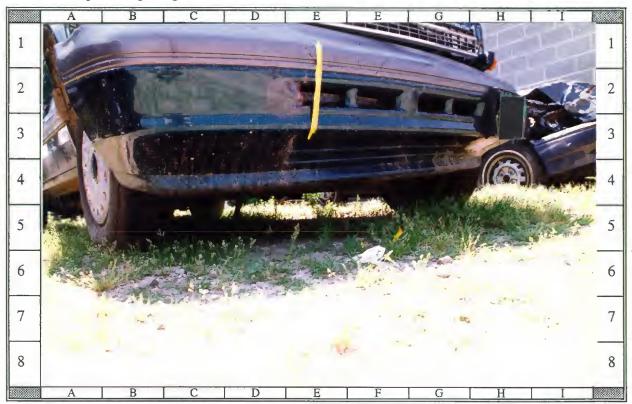
#38: Ground level view of Case Vehicle's air dam, from approximately 15 degrees right of front, which contacted ground prior to sign pole impact

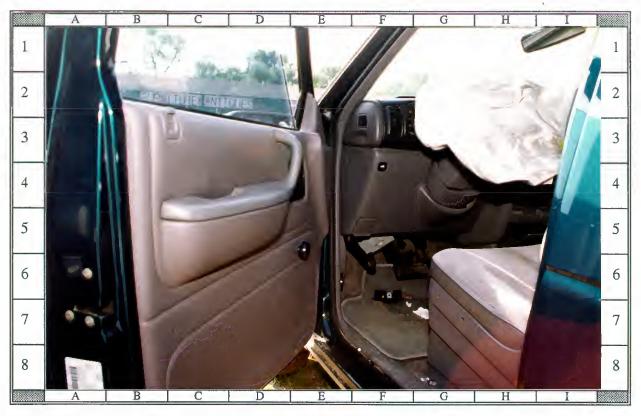
39: Interior surface of Case Vehicle's driver door panel and deployed driver's side air bag and knee bolster viewed from outside driver's door

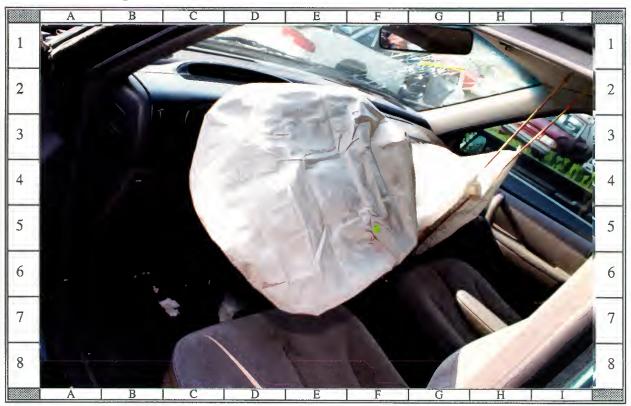
40: Case Vehicle's front seating area and deployed air bags showing contact to driver's air bag; NOTE: lipstick mark on driver's air bag (green dot)

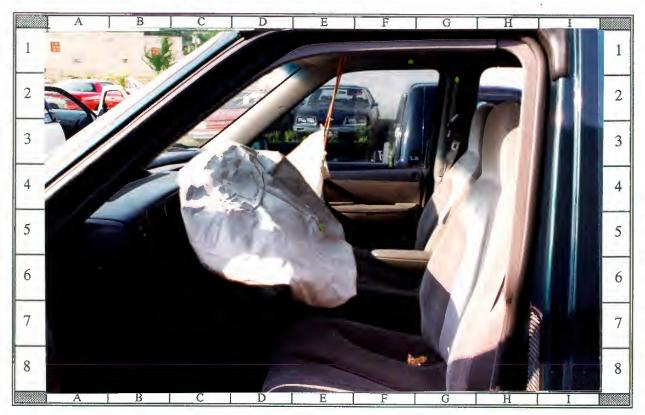
41: Case Vehicle's front seating area and deployed air bags; NOTE: right front passenger contacts to right roof side rail and right "B"-pillar (green dots)

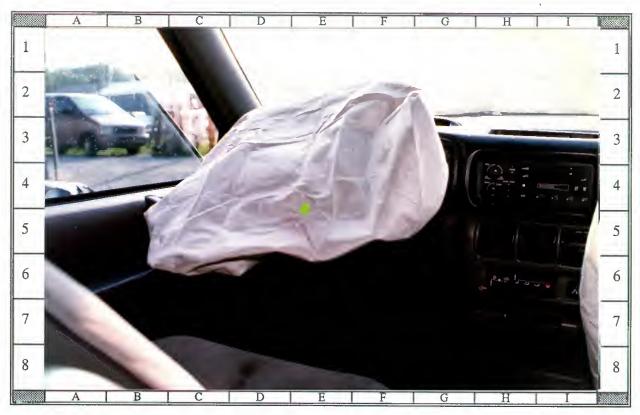
43: Case Vehicle's contacted driver side air bag, center dash, and noncontacted knee bolster viewed from rear center seat

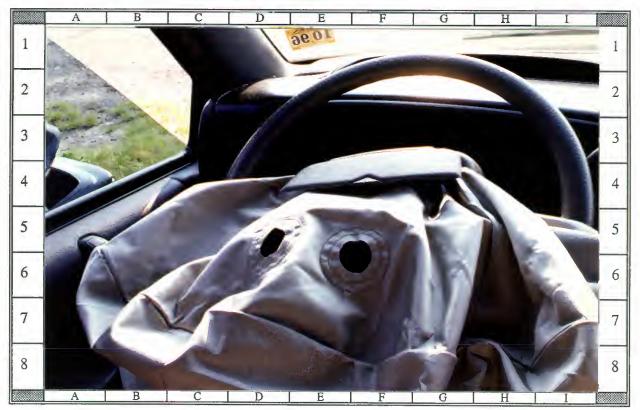
44: Case Vehicle's driver side air bag module showing air bag's vent ports, noncontacted steering wheel rim, and module's top cover flap

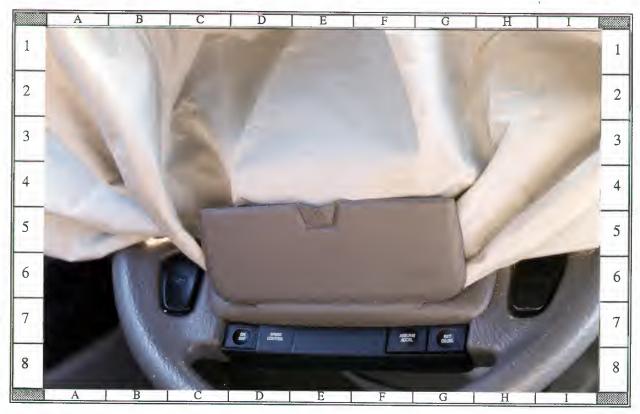
45: Close-up of Case Vehicle's driver side air bag module showing no evidence of contact to module's bottom cover flap

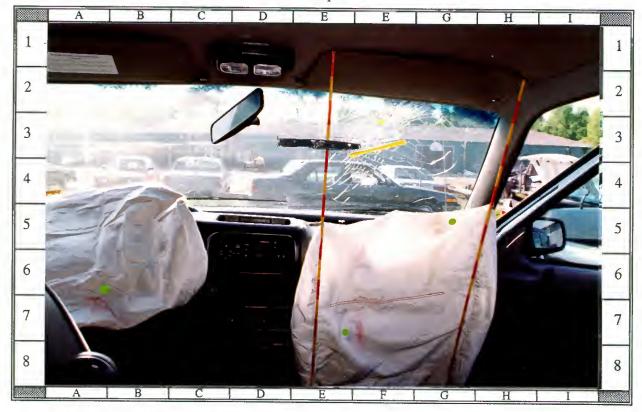
46: Case Vehicle's deployed air bags, front dash, and rearview mirror; NOTE: contacts to both air bags (green dots) and windshield (yellow tape)

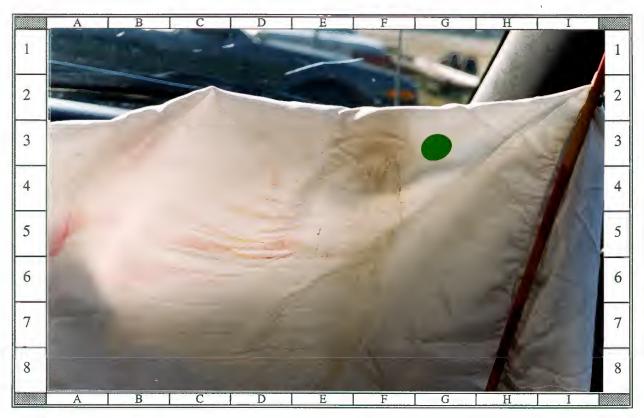
49: Close-up of contact to right upper portion of Case Vehicle's right front air bag showing a large amount of skin transfer and an unknown red smear

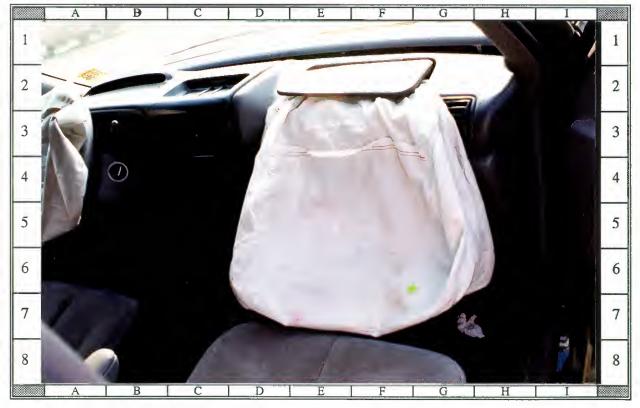
50: Top portion of Case Vehicle's right front air bag showing module's cover flap and skin and red substance smearing near right upper portion of air bag

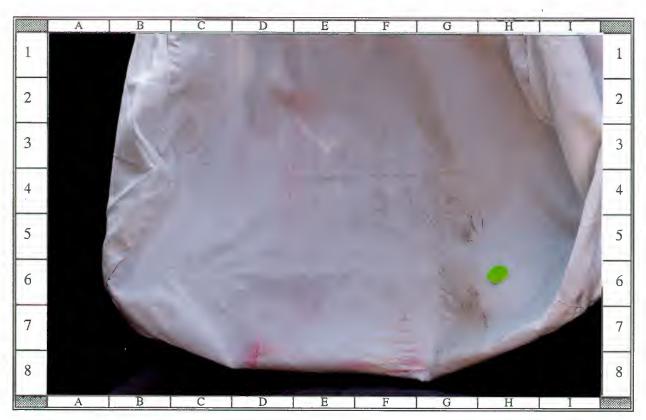
51: Close-up of contact evidence to upper portion of Case Vehicle's right front air bag; NOTE: green dot is identical to green dot shown in Photo #49 above

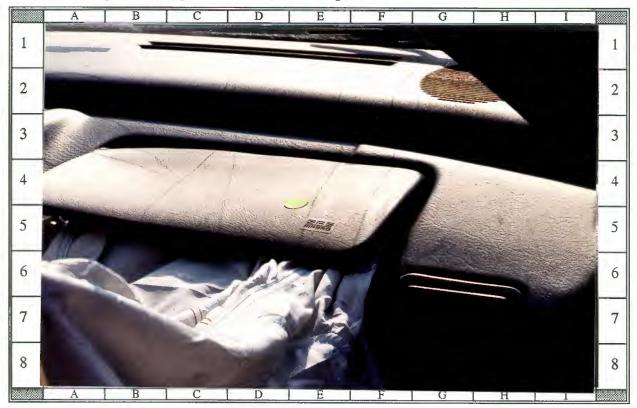
found during the case vehicle's inspection and the medical description⁸ of the resulting fatal⁹, atlanto-occipital dislocation that the front right passenger sustained, it appears that the contact with the air bag module's cover flap and the air bag itself pushed the occupant's head upwards and forward while the occupant's torso was being "held-in-place" or pushed initially backwards. In this contractor's opinion, the deploying air bag caused the child to brush the windshield¹⁰ (i.e., an oil smear was identified--see Selected Photograph #54), prior to being thrown rearward and to the right¹¹. During her rebound, the front right passenger contacted the right front roof side rail and "B"-pillar with the back of her head (oil smears) and neck. After contacting of the roof side rail and "B"-pillar, the front right child passenger most likely landed on her seat, and her head contacted the base of the seat back (i.e., skin and blood--see Selected Photograph #60).

52: Close-up of cover flap from Case Vehicle's right front air bag module showing contact (oil smudge) from right front passenger's chin/neck

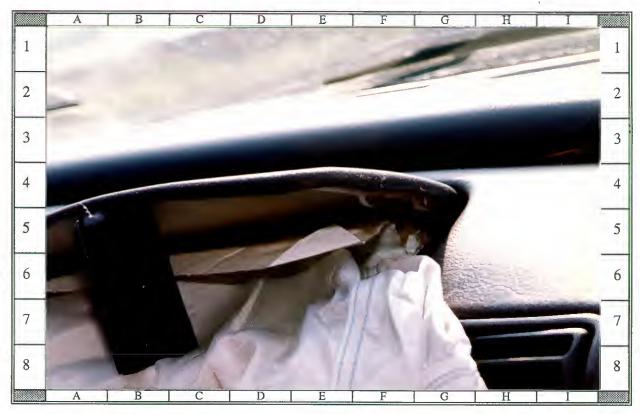
53: Close-up of cover flap's corner edge from Case Vehicle's right front air bag module showing contact evidence (skin) from passenger's neck/chin

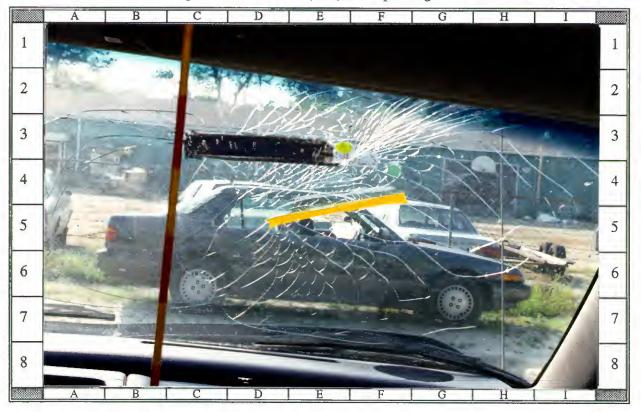
54: Case Vehicle's windshield showing evidence of contact (smear above/along yellow tape) from right front passenger's head

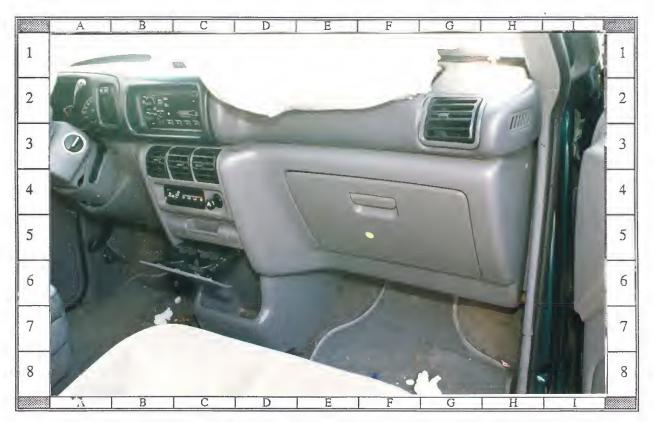
55: Case Vehicle's glovebox showing scuff mark most likely from right front passenger's lower extremities

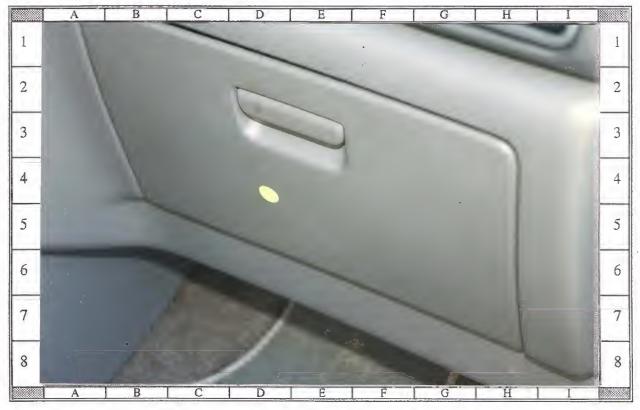
56: Close-up of scuff mark on Case Vehicle's glovebox

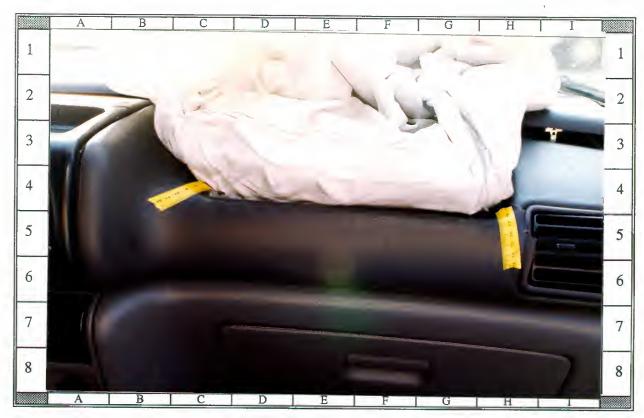
57: Case Vehicle's right dash showing tears (yellow tape) in dash which occurred during right front air bag's deployment; NOTE: separation (cell I3)

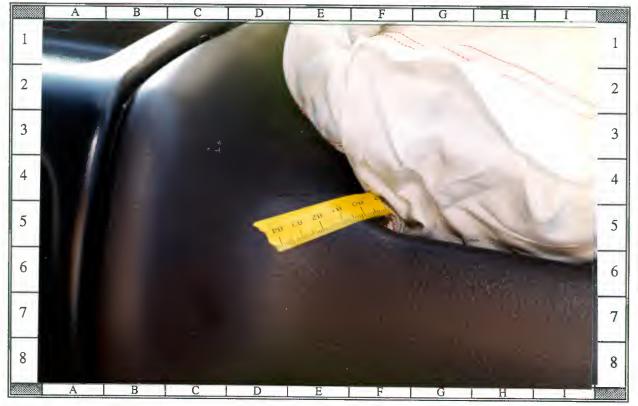
58: Close-up of tear to Case Vehicle's dash near left lower corner of right front air bag module's compartment

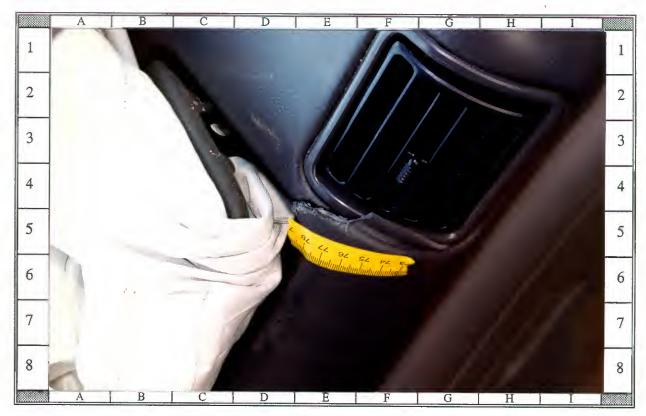
59: Close-up of tear to Case Vehicle's dash near right lower corner of right front air bag module's compartment

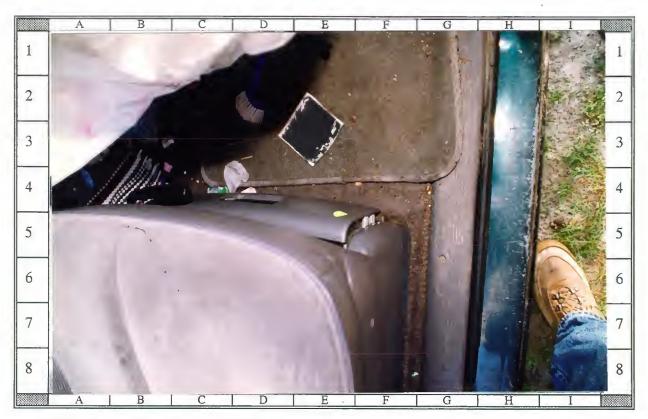
The case vehicle's subsequent impacts with the ground and sign post then sent the child forward onto the floorboard where she came to rest. The child's final rest position was confirmed by statements on her medical records and a blood spot found on the front of the auxiliary glove box located underneath the front right passenger's seat; see **Selected Photographs** #61 and #62.

61: Case Vehicle's right front passenger seat showing blood spot on vertical surface (green dot) of auxiliary glovebox underneath seat

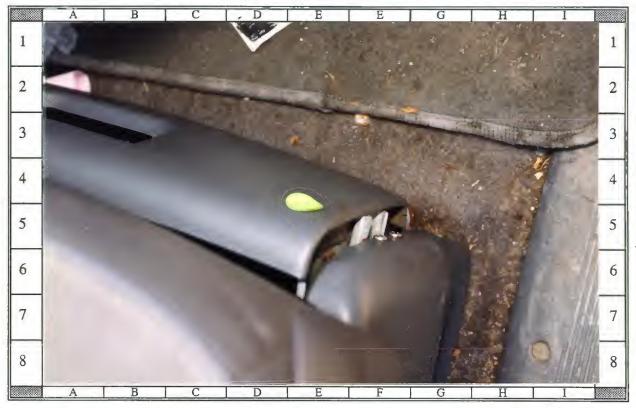
62: Close-up of blood spot on vertical surface of auxiliary glovebox underneath Case Vehicle's right front passenger seat

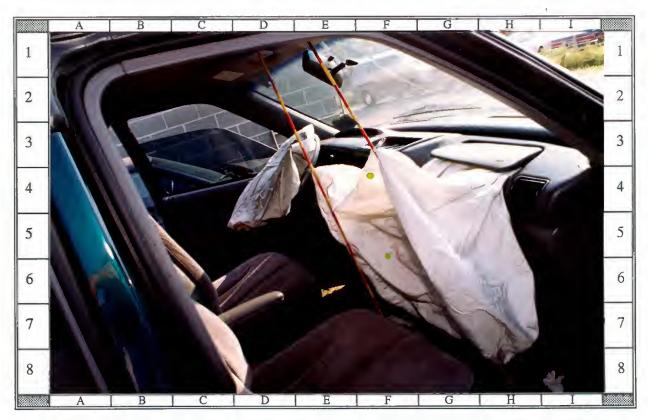
63: Case Vehicle's front seating area and deployed air bags viewed from outside right front passenger's door

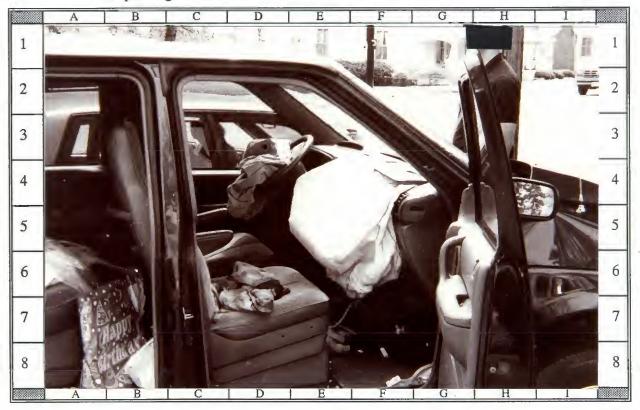
64: On-scene view of Case Vehicle's front seating area and deployed air bags viewed from outside right front passenger's door

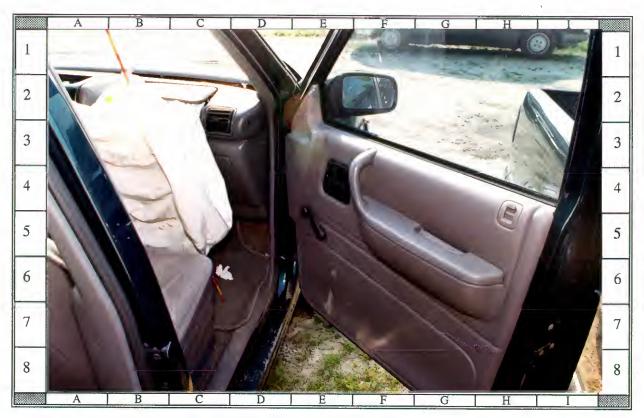
65: Interior surface of Case Vehicle's right front passenger door panel and deployed air bag; NOTE: no contact evidence to door panel

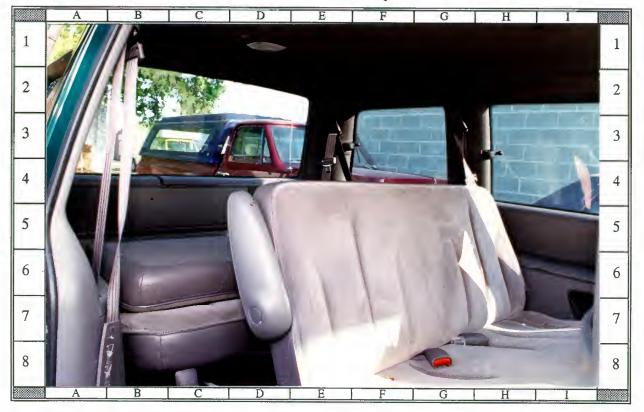
66: Case Vehicle's second seating area where two three year-olds were seated in booster seats of unknown type; NOTE: 3-point safety belts at outboard positions

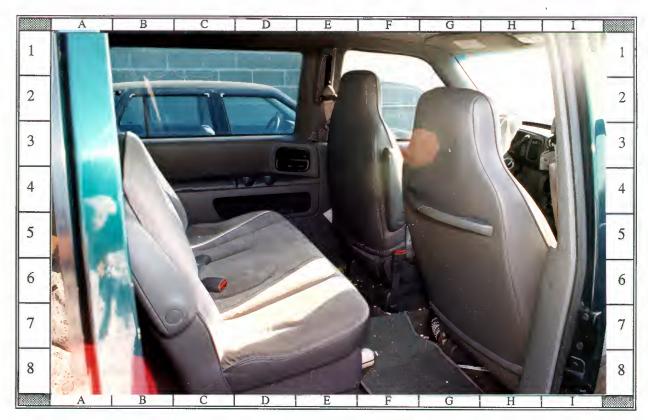
67: Case Vehicle's second seating area and front seatbacks which showed no evidence of contacts from second seat passengers

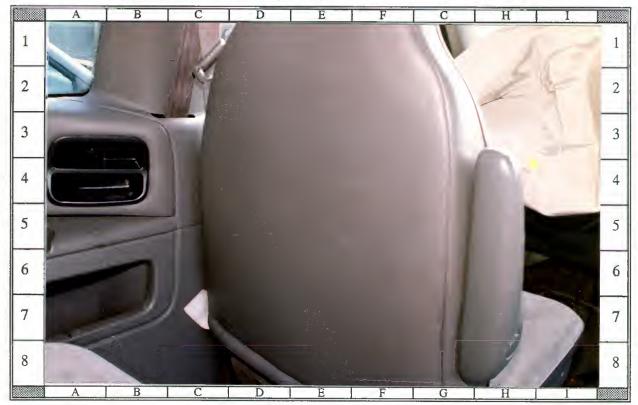
68: Close-up of Case Vehicle driver's seatback; NOTE: no evidence of contact from left second-seated passenger

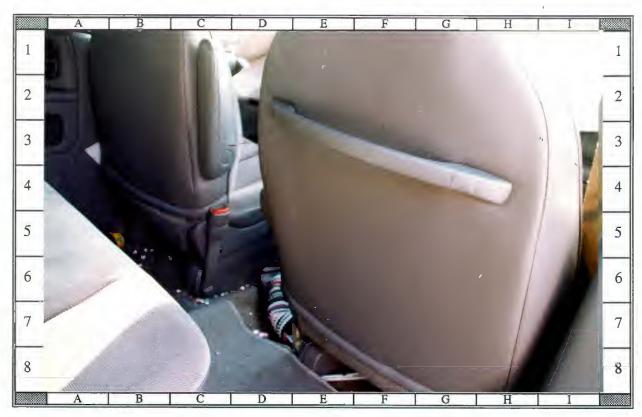
69: Close-up of Case Vehicle passenger's seatback; NOTE: no evidence of contact from right second-seated passenger

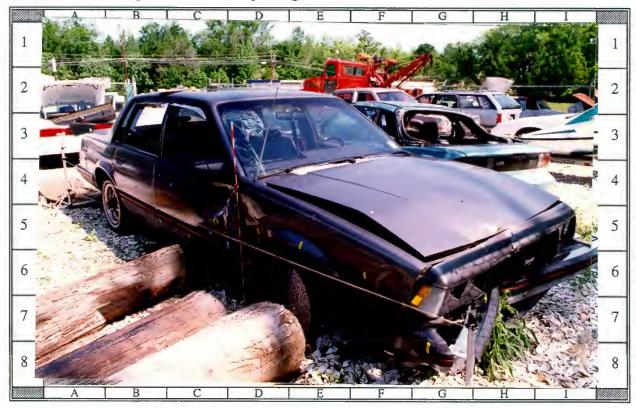
70: 1986 Chevrolet Celebrity's damaged right side, viewed from approximately 45 degrees right of front, from initial impact with Case Vehicle

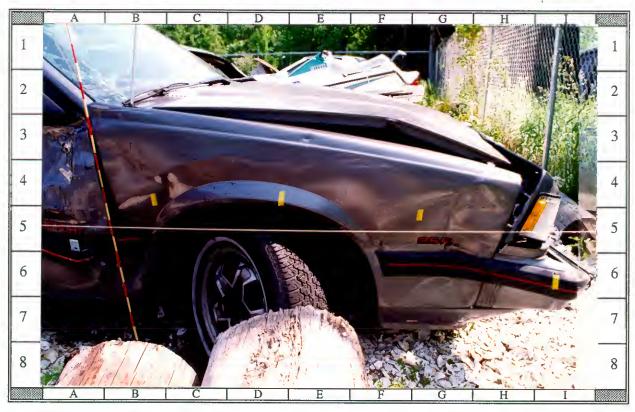
#71: Close-up of direct damage to Vehicle #2's right front fender viewed from right

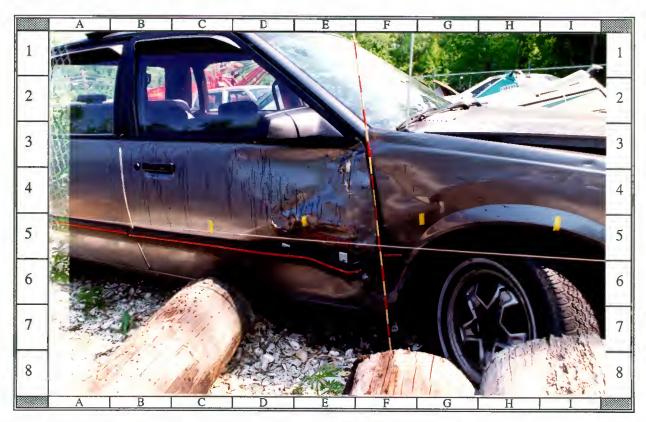
72: Close-up of direct damage to Vehicle #2's right front fender and passenger door viewed from approximately 75 degrees right of front

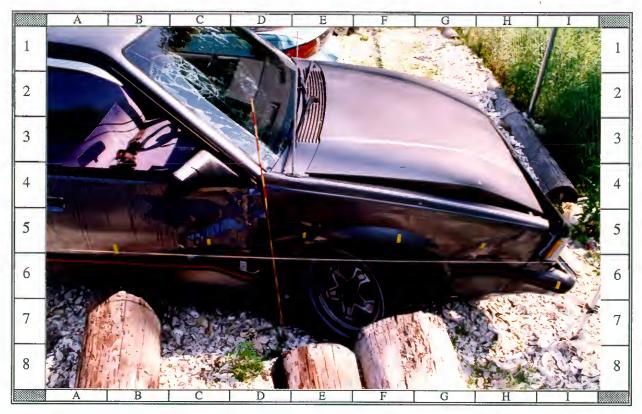
73: Right overhead view of Vehicle #2's damaged right side; NOTE: yellow tape represents C-measurements and spiderweb pattern to right windshield

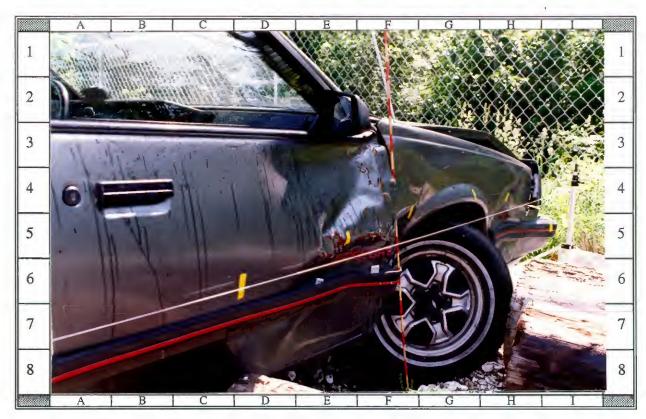
75: Close-up of Vehicle #2's right side deformation viewed from approximately 60 degrees right of back

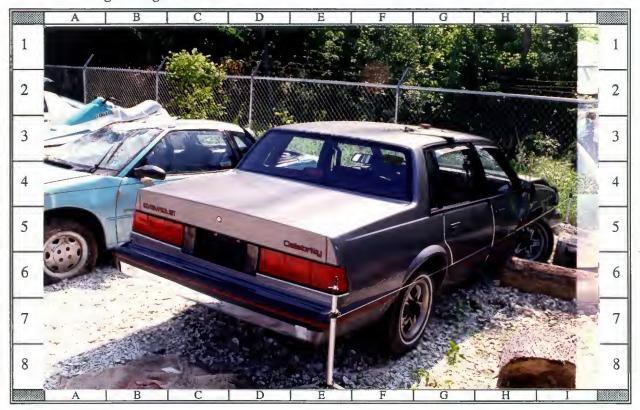
76: Vehicle #2's undamaged right back side and back viewed from approximately 45 degrees right of back

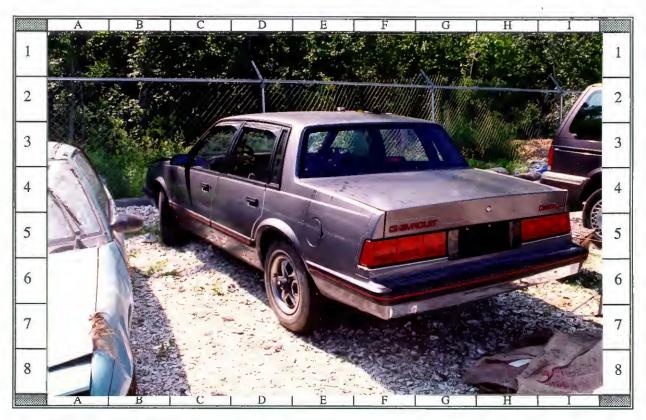
77: Vehicle #2's undamaged back and left side viewed from approximately 45 degrees left of back

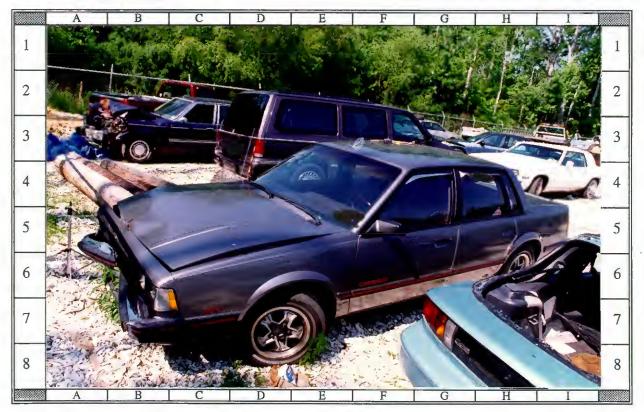
78: Vehicle #2's damaged front and undamaged left side viewed from approximately 75 degrees left of front; NOTE: frontal impact was from utility pole

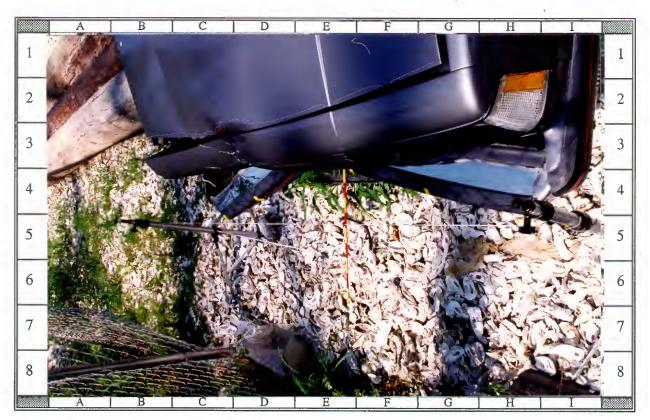
79: Reference line view of Vehicle #2's frontal damage from left; NOTE: frontal impact was from utility pole

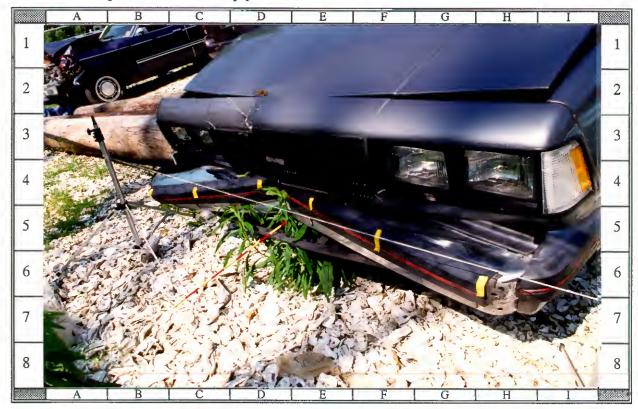
80: Close-up of Vehicle #2's frontal damage from impact with utility pole viewed from approximately 60 degrees left of front

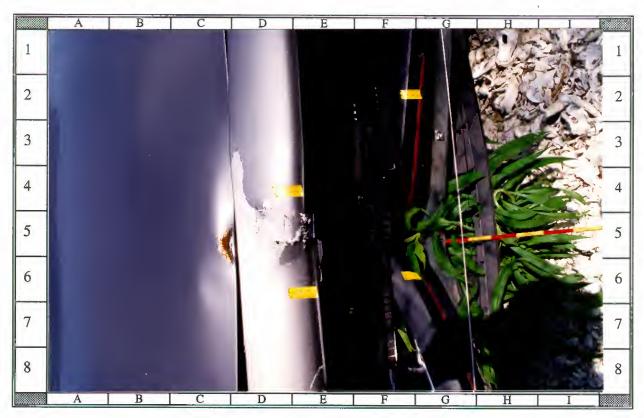
81: Close-up of Vehicle #2's direct damage from impact with utility pole; NOTE: narrow impact area

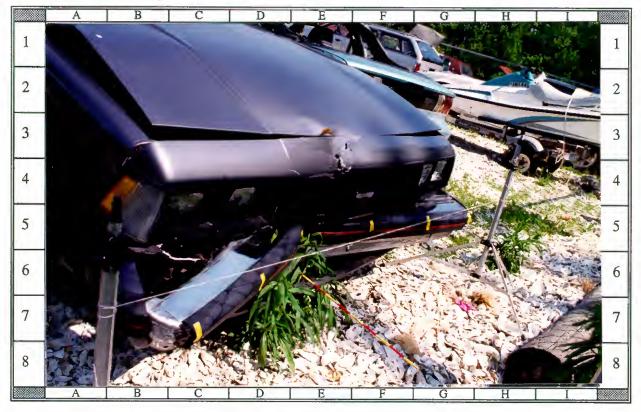
82: Close-up of Vehicle #2's frontal damage from impact with utility pole viewed from approximately 45 degrees right of front
